611-132  
VIKING 75 ORBITER  
SYSTEM TEST AND LAUNCH OPERATIONS  
FINAL REPORT  
VOLUME 1: SYSTEM TEST

January 31, 1977

JET PROPULSION LABORATORY  
CALIFORNIA INSTITUTE OF TECHNOLOGY  
PASADENA, CALIFORNIA

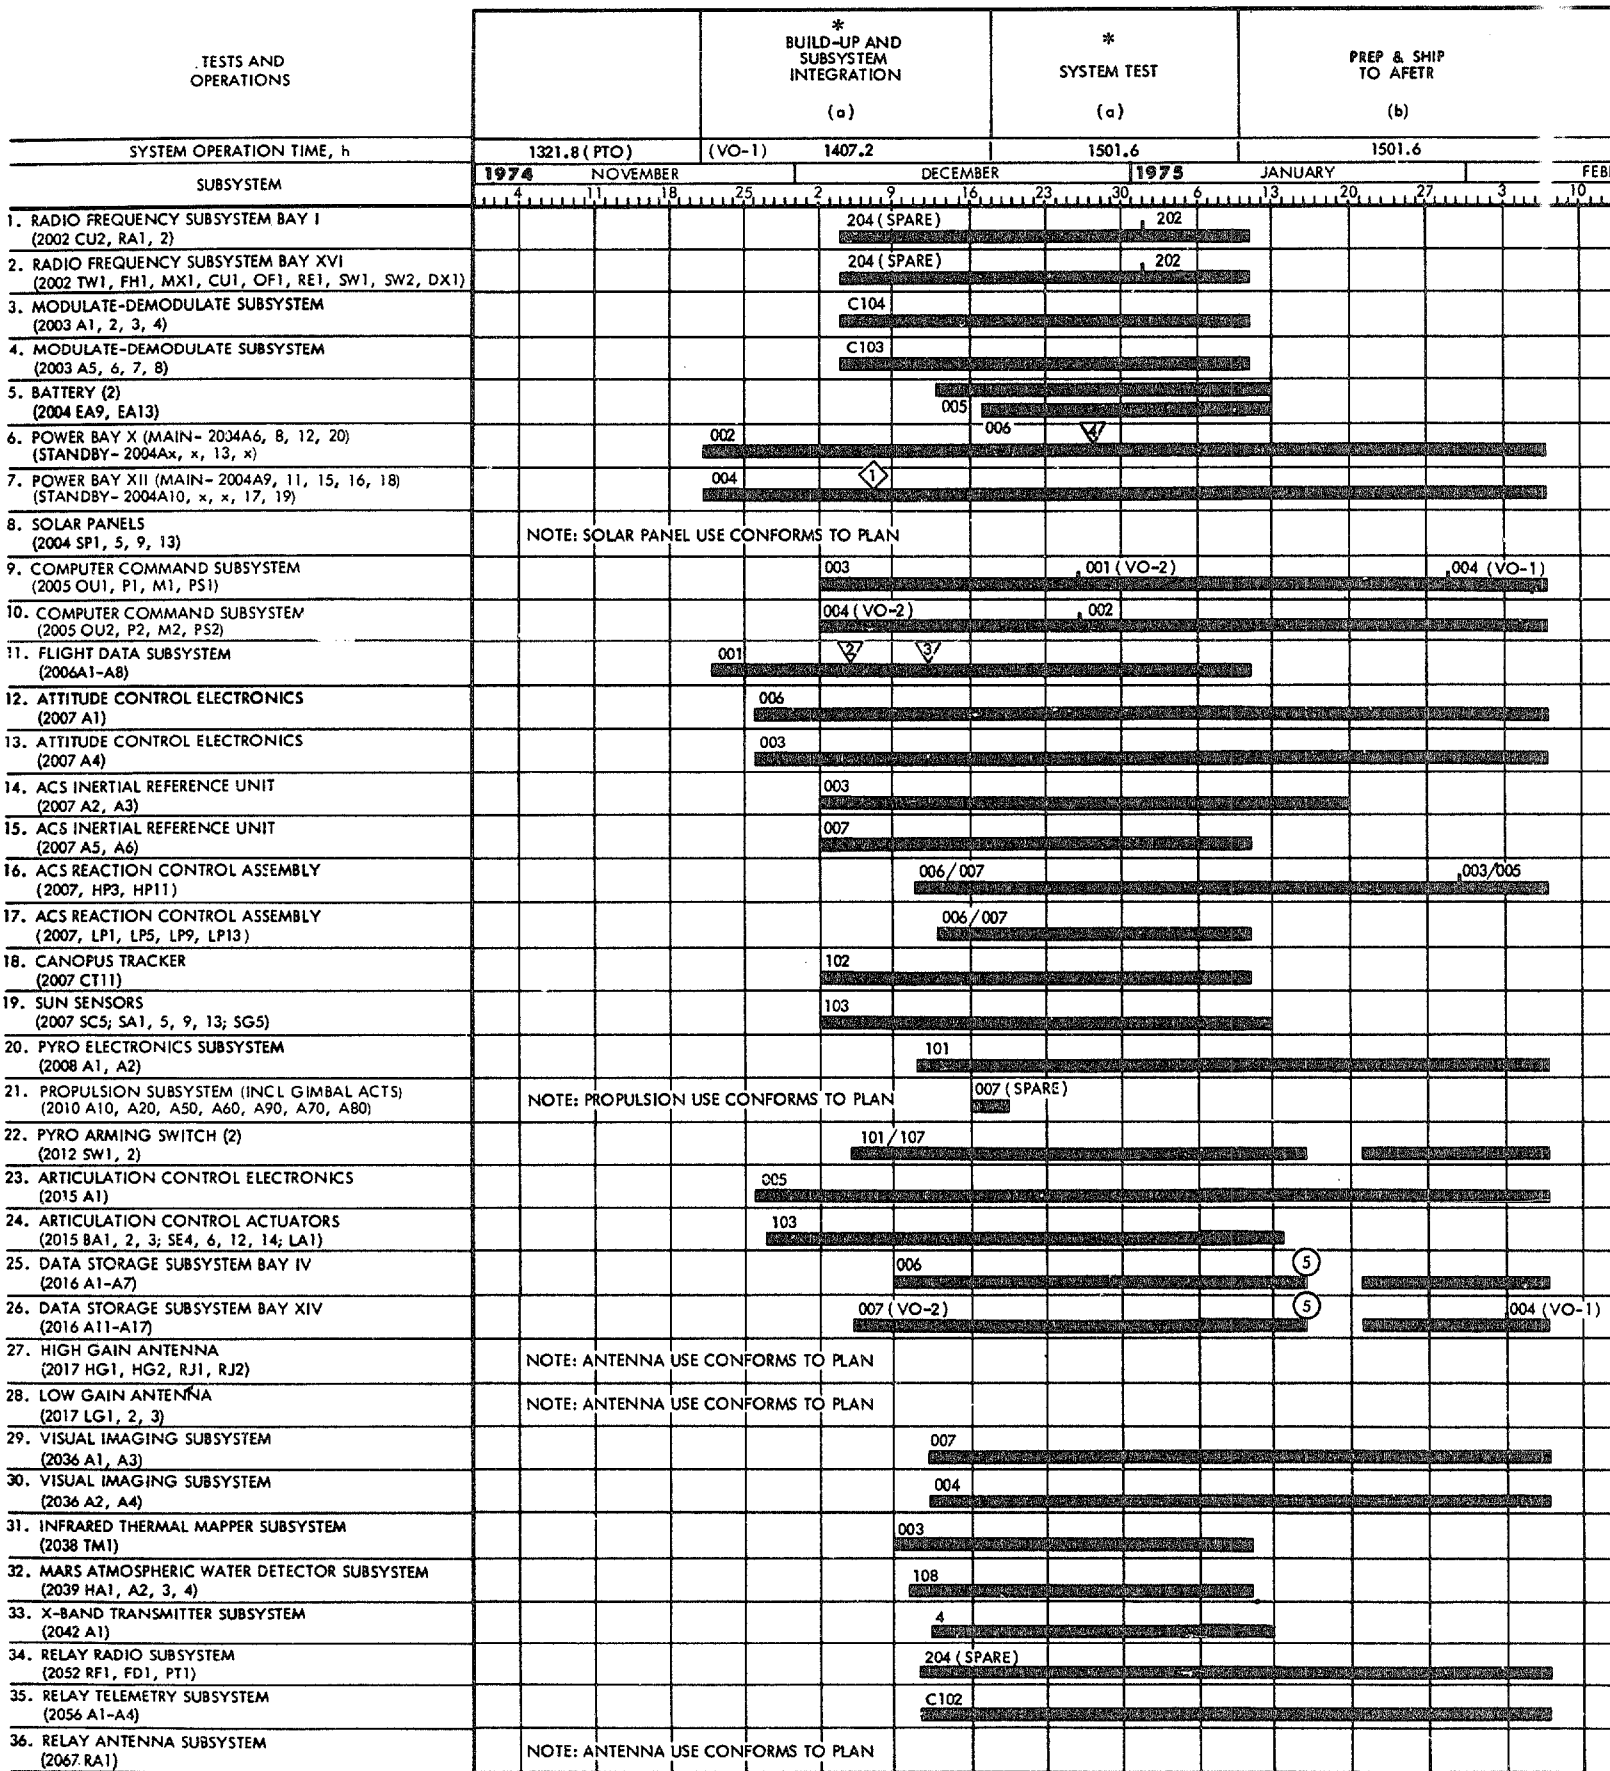
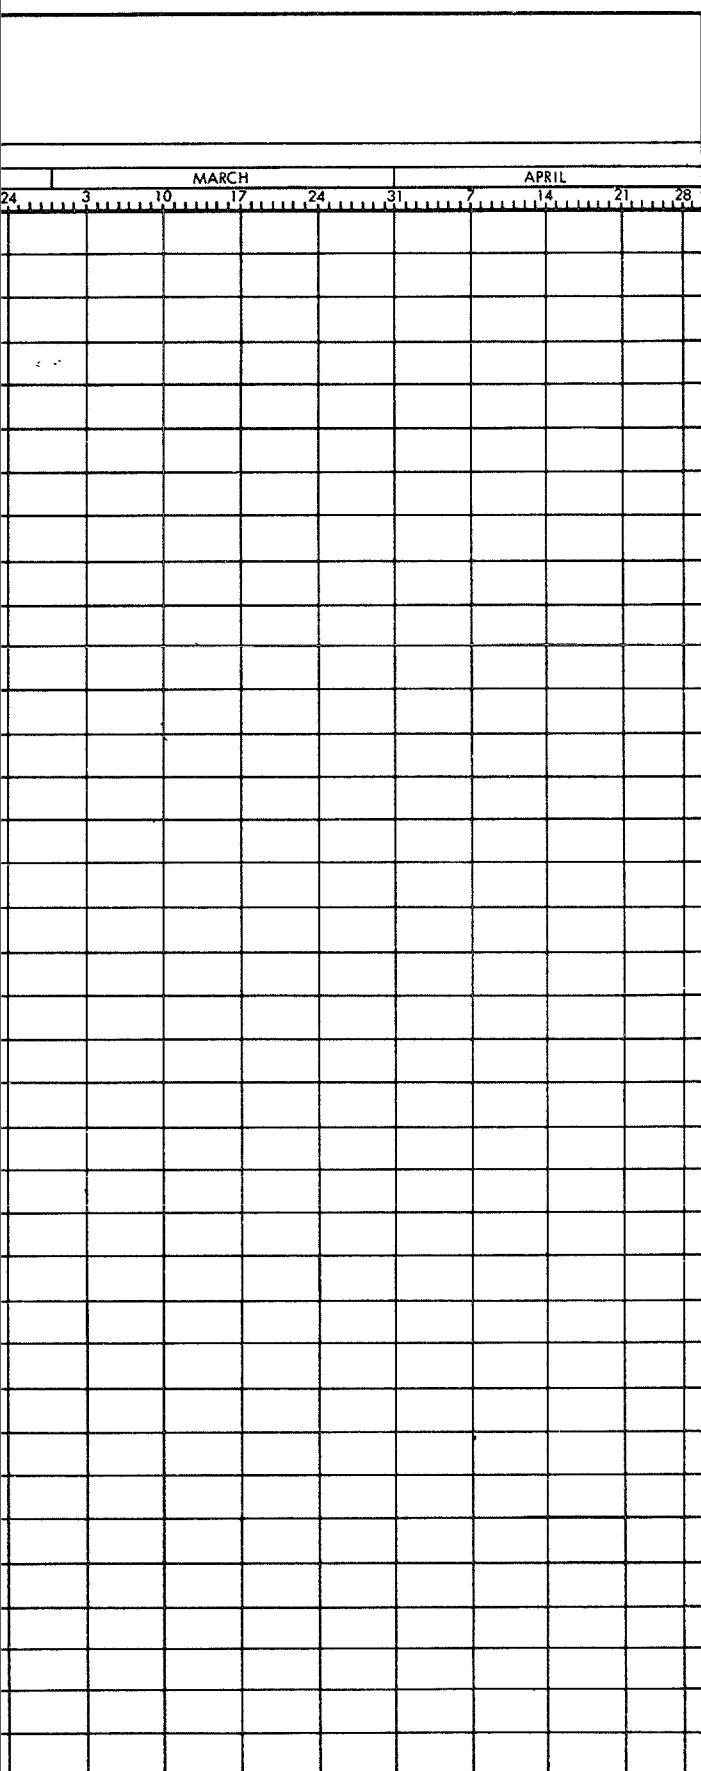
Figure 5.  
VO-1 Subsystem History

- 12-6-74 ① 4A11 S/N 004, HGA HEATER FUSES OPEN, P/FR 34462. RE-INSTALLED 12-16-74 (S/N 002 INSTALLED DURING REPAIR). R/RC 170682
- 12-5-74 ② 6A3 S/N A102 FOR ECR 18091, CHANGE PHASE OF 32 kHz CLOCK. RE-INSTALLED 12-9-74. R/RC 170680
- 12-11-74 ③ 6A4 AND 6A7 S/N A102 FOR ECR 18100, MEMORY LOAD ERROR MOD. RE-INSTALLED 12-11-74. R/RC 170683. BOTH UNITS REMOVED AGAIN ON 12-12-74 TO CORRECT WIRING ERROR MADE DURING ECR MOD. RE-INSTALLED 12-12-74. R/RC 16255
- 12-27-74 ④ 4A20 S/N 004 FOR ECR 18070, INCREASE CONVERTER LOAD CAPACITY. (4A20 S/N 005 INSTALLED DURING MOD). RE-INSTALLED 1-22-75. R/RC 16207
- 1-16-75 ⑤ DSS S/N 006 & 007 REMOVED FOR CALIBRATION AND REDUNDANT ELEMENT VERIFICATION. RE-INSTALLED 1-21-75. R/RC 170579 & 170580.

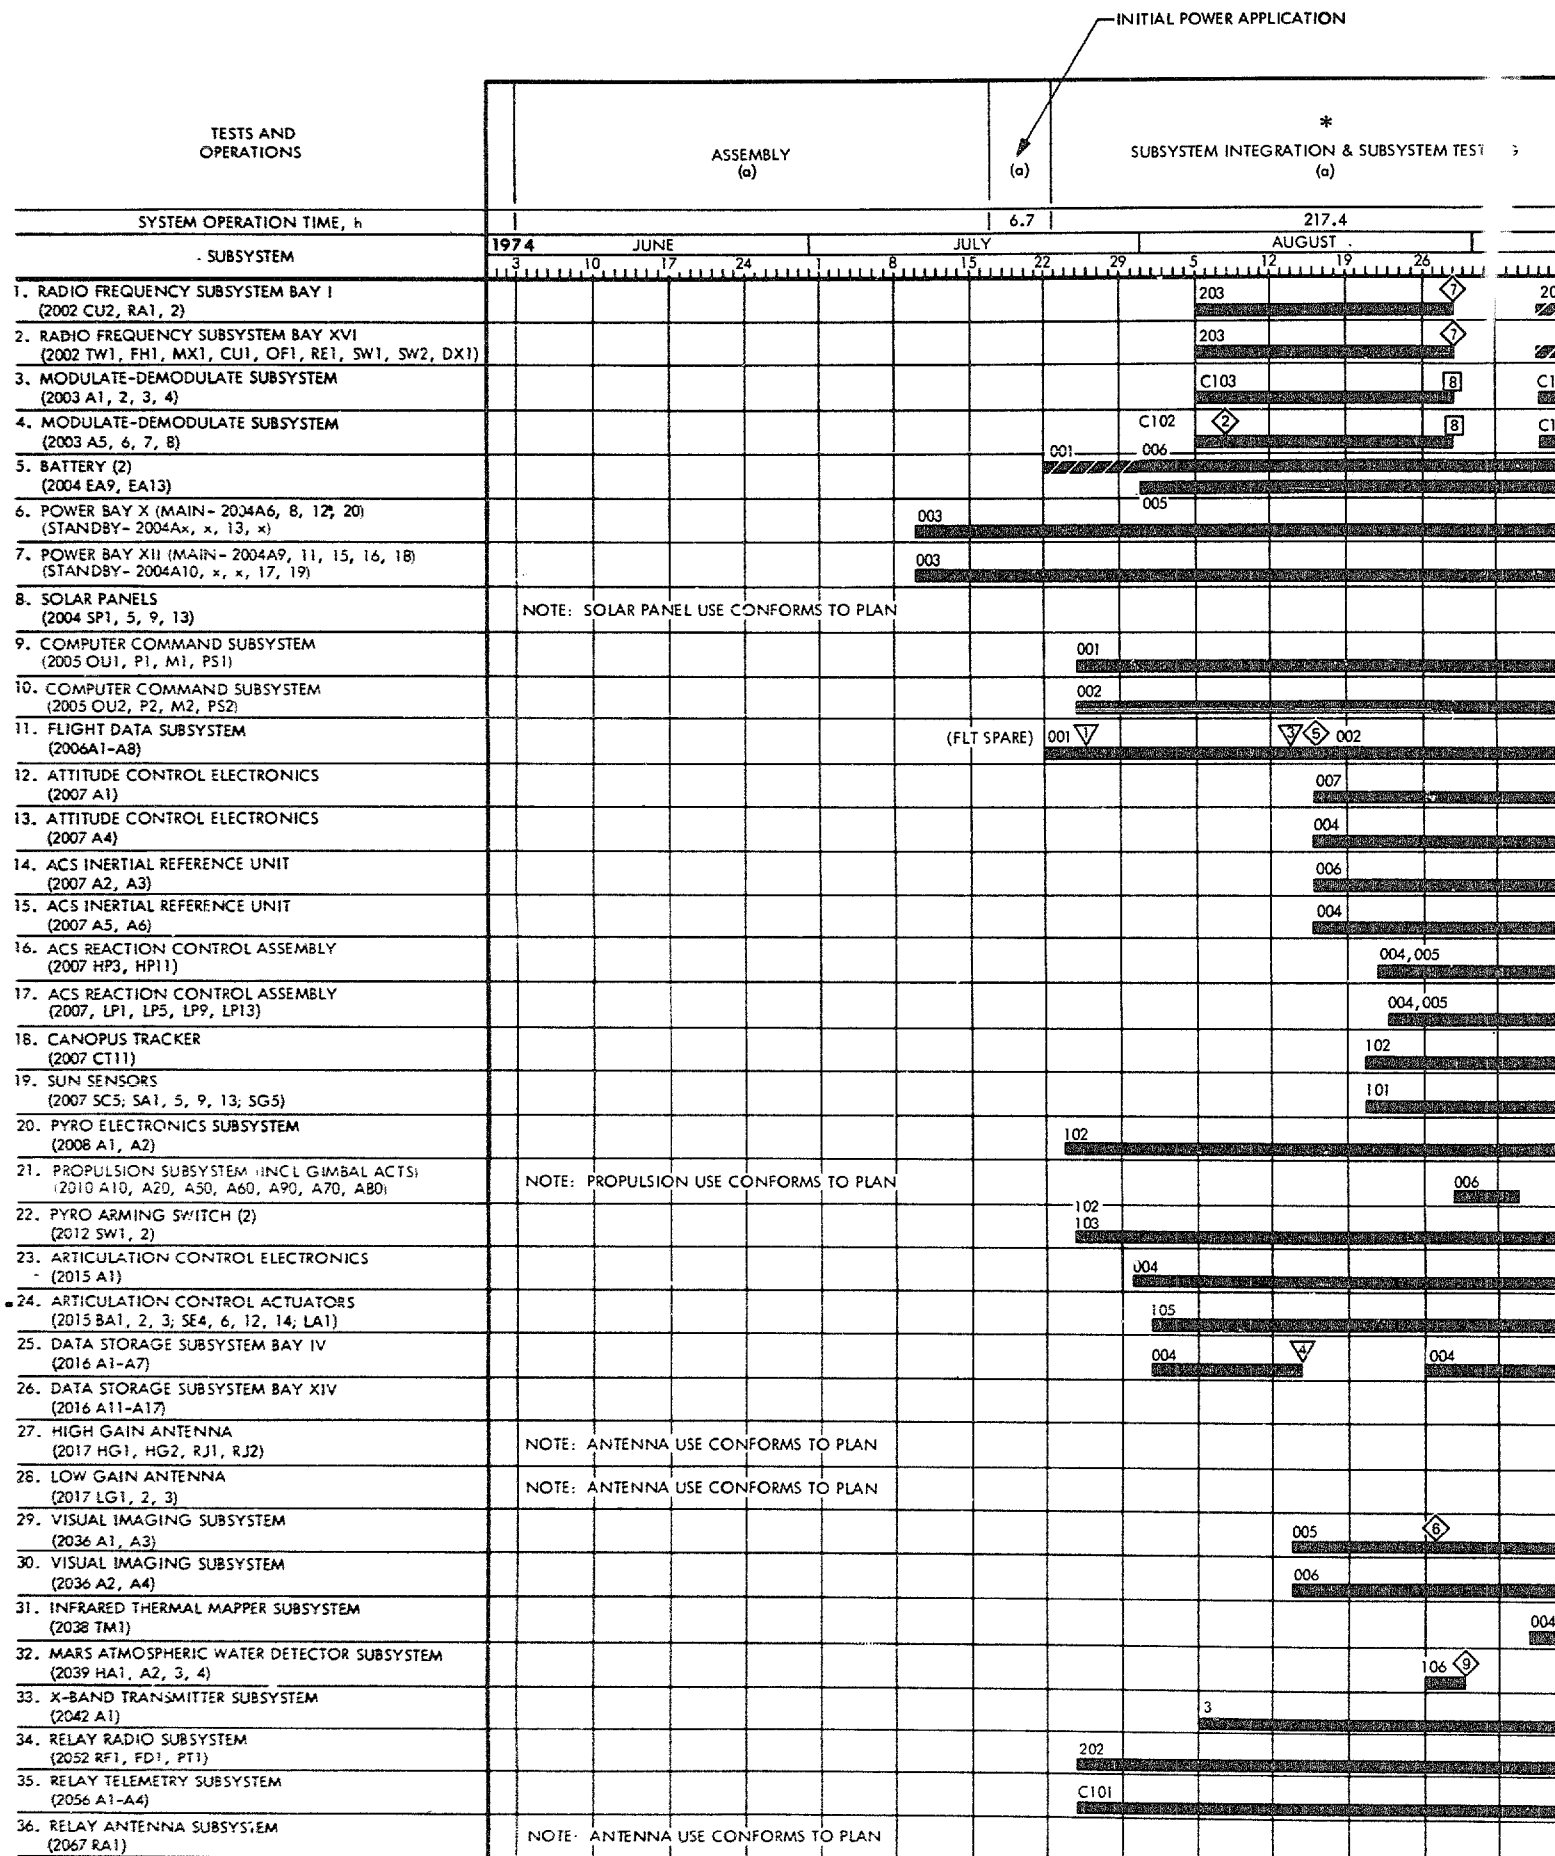
Figure 6.  
VO-2 Subsystem History

DS 6A7 SNA103 RETURNED TO DIVISION TO CHECK FOR IMPROPER DATA FOR VIS B  
CONTROL WORD AND INCORRECT RESPONSE TO COMMAND PER P/R 34634 AND 34635.  
REPLACED AN IC 54L95 IN THE 6A7A2. RE-INSTALLED 9-3-74. R/C 16056.

DS 36A4 SN005 RETURNED TO DIVISION TO CHECK FOR LACK OF CONTINUITY  
FROM CONNECTOR TO GROUND. FOUND GROUND LUG SCREW NOT TIGHTENED. AREA WAS  
CLEANED, SCREW PROPERLY TORQUED AND AREA RE-COATED. RE-INSTALLED 8-29-74.  
R/C 16065.

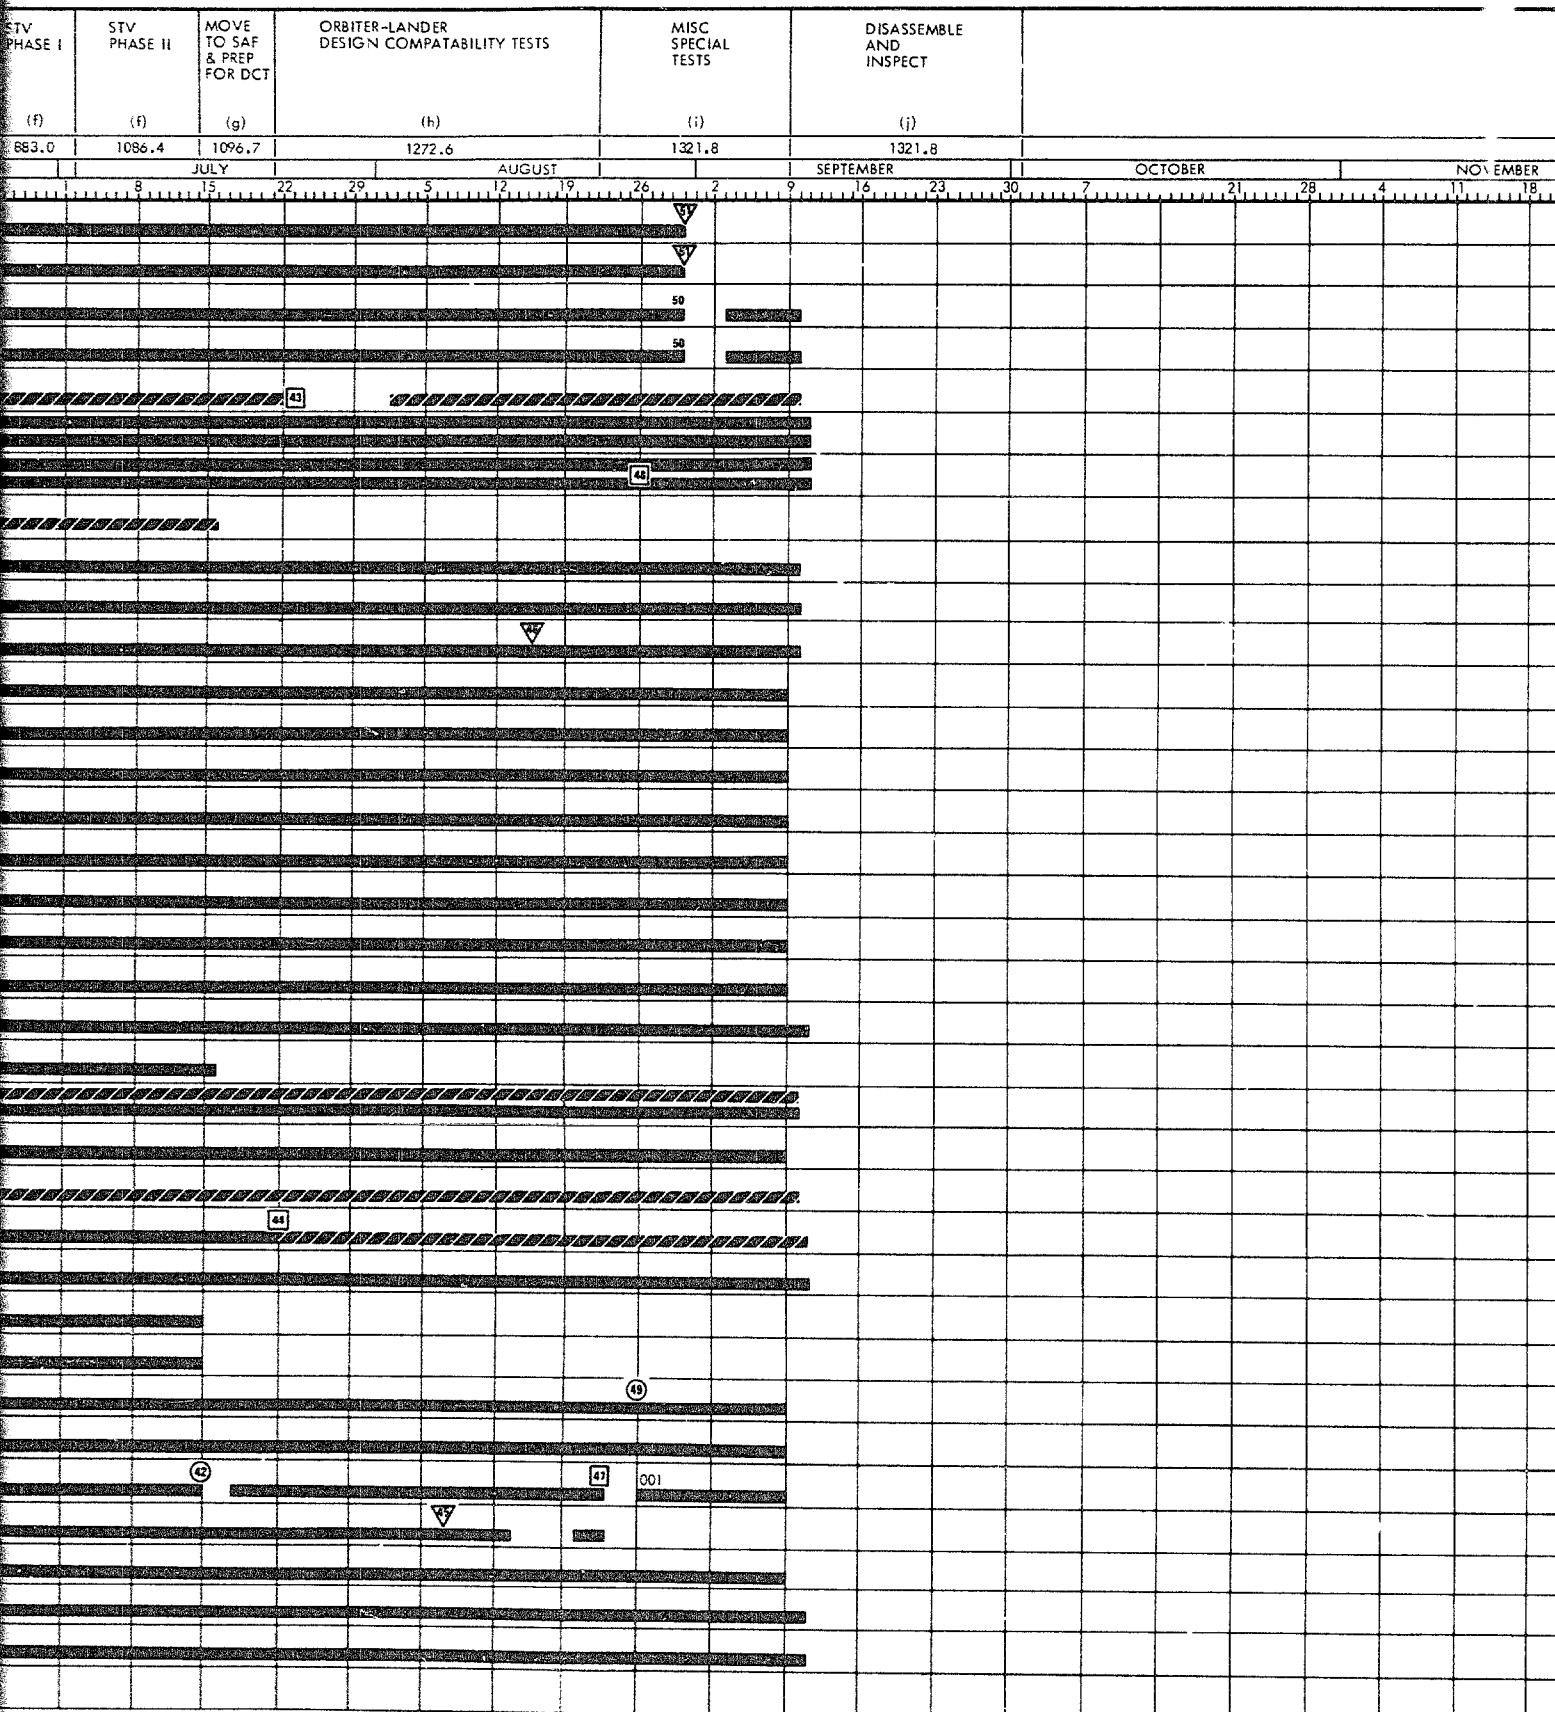
# VIKING ORBITER 1975 VO-1 S/C HISTORY (PTO)

- 1-21-74 POWER BREADBOARD 4A10 BOOSTER REGULATOR OUT OF TOLERANCE. RETURNED TO DIV 1-21-74 AND FOUND LOOSE CKT BOARD, BOARD WAS PLUGGED IN PROPERLY AND SECURED WITH SCREWS. REINSTALLED 1-21-74 P/FR 34009, R/RC 16425. PPM 4A17 S/N002 RETURNED TO DIV 1-21-74 FOR EVALUATION. REINSTALLED 1-21-74 R/RC 16426. BOTH UNITS RETURNED TO DIV 1-22-74, BB 4A10 HAD COLD SOLDER JOINT, 4A17 HAD STYCAST BROKEN AT STANDOFF. BOTH UNITS REINSTALLED 4-22-74. R/RC 138074 AND R/RC 138073. 4A10BB REMOVED AGAIN ON 1-25-74 TO BONDED STORES.

- 1-29-74 POWER PPM MODULES REMOVED, REPLACED WITH PTO 4A6, 4A8, 4A12 AND 4A20 ALL S/N002.
- 2-8-74 CCS HARNESS 9W5/9W55 REMOVED, CONNECTOR PINS COATED WITH RESIDUE. CONNECTORS CLEANED AND GIVEN PIN RETENTION TEST, PASSED TEST, REINSTALLED 2-11-74. P/FR 34026 R/RC 16429.

- 3-21-74 CCS S/NPT1 REMOVED TO INSPECT CONDUCTIVE RESIDUE FOUND ON A FEW PINS, THESE MODULES REINSTALLED 3-22-74 AFTER A CLEANING THREE TIMES.
- 3-22-74 PWR PTO 4A20 S/N002 TO BENCH TEST FOR OVERLOADED DURING PROP ISOLATION TEST AT SAF ON 3-18-74, P/FR 34117. PPM STRESS FOUND. REINSTALLED 3/26/74.

- 3-29-74 SUN SENSOR 75C5 S/N102 RETURNED TO DIV 1-21-74. LOOSE INSERT. REINSTALLED 4-1-74. R/RC 170024. REMOVED AGAIN 4-3-74 TO FIX BIASING. REINSTALLED 4-4-74. R/RC 170042.

- 4-22-74 IRTM RETURNED TO DIVISION FOR REPAIR AND TO RE-CHARGE DETECTORS. REINSTALLED 4-27-74. R/RC 16475.
- 4-26-74 MAWD HEAD REMOVED TO RE-ROUTE CABLES OF CONNECTOR. REINSTALLED 4-27-74.

- 5-1-74 VIS S/N004 TO CHANGE BIAS RESISTORS TO 10K OHM PER ECR 17820. REINSTALLED 5-1-74.
- 5-23-74 RFS TWTA-2 CONTROL UNIT FAILURE ON DIVISION AND SUBSEQUENT TESTS CONTINUED. UNIT REPAIRED AND TWTA-2 REPLACED. R/RC 170183.
